**DEPARTMENT OF TRANSPORTATION**

Contract #: 04-0120F4Cty: SF/ALA Rte: 80 PM: 13.2/13.9File #: 1.28**WELDING INSPECTION REPORT****Resident Engineer:** Casey, William**Address:** 333 Burma Road**City:** Oakland, CA 94607**Report No:** WIR-026544**Date Inspected:** 19-Oct-2011**Project Name:** SAS Superstructure**OSM Arrival Time:** 700**Prime Contractor:** American Bridge/Fluor Enterprises, a JV**OSM Departure Time:** 1730**Contractor:** American Bridge/Fluor Enterprises, a JV**Location:** Job Site**CWI Name:** William Sherwood**CWI Present:** Yes No**Inspected CWI report:** Yes No N/A**Rod Oven in Use:** Yes No N/A**Electrode to specification:** Yes No N/A**Weld Procedures Followed:** Yes No N/A**Qualified Welders:** Yes No N/A**Verified Joint Fit-up:** Yes No N/A**Approved Drawings:** Yes No N/A**Approved WPS:** Yes No N/A**Delayed / Cancelled:** Yes No N/A**Bridge No:** 34-0006**Component:** SAS OBG**Summary of Items Observed:**

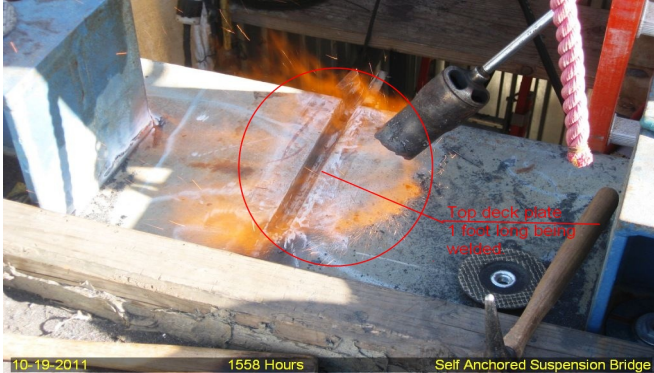
At OBG 12W/13W top deck plate A5 outside, ABF welder Jorge Lopez was noted preheating the plates to more than 200 degrees Fahrenheit using propylene gas torch prior welding.

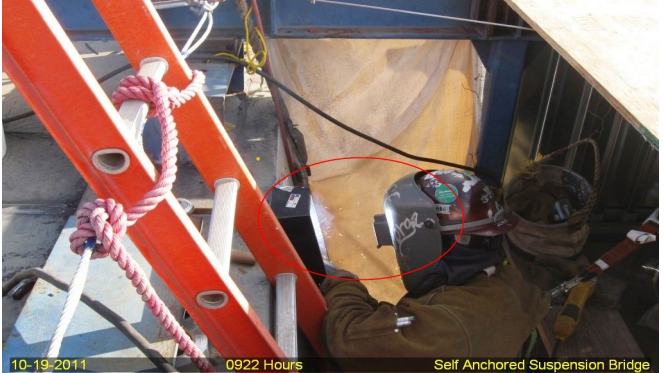
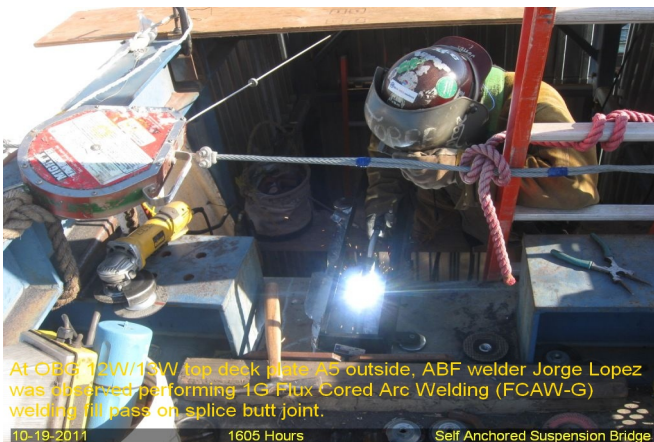
At OBG 12W/13W edge plate 'F' outside, ABF welder Jorge Lopez was observed performing 3G Flux Cored Arc Welding (FCAW-G) welding fill pass to cover pass to replace butt joint.
